CCR Unit: SCA #2 Ash Landfill

Owner: Sunnyside Cogeneration Associates

Annual Inspection: January 2026

This annual inspection has been completed by S. Scott Carlson, PE 187727 in accordance with CCR Rules § 257.84 (b) and Utah State code R315-319-84.

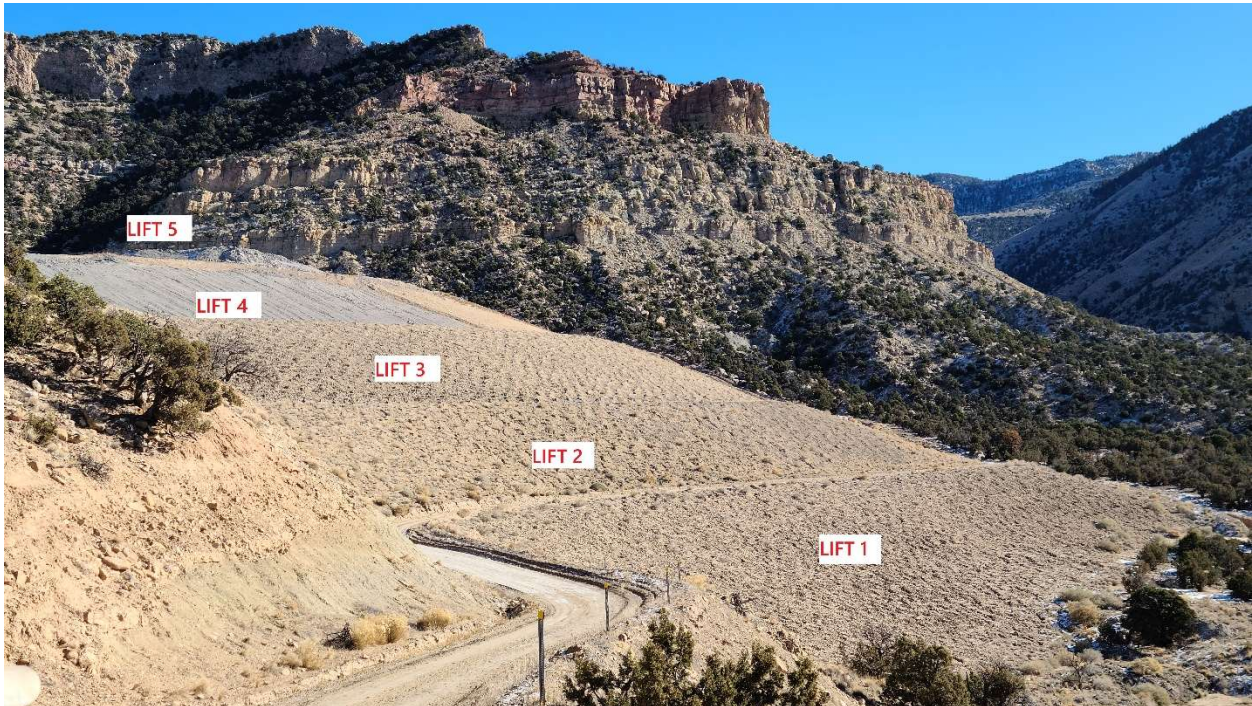
SCA#2 Ash Landfill – looking southeasterly

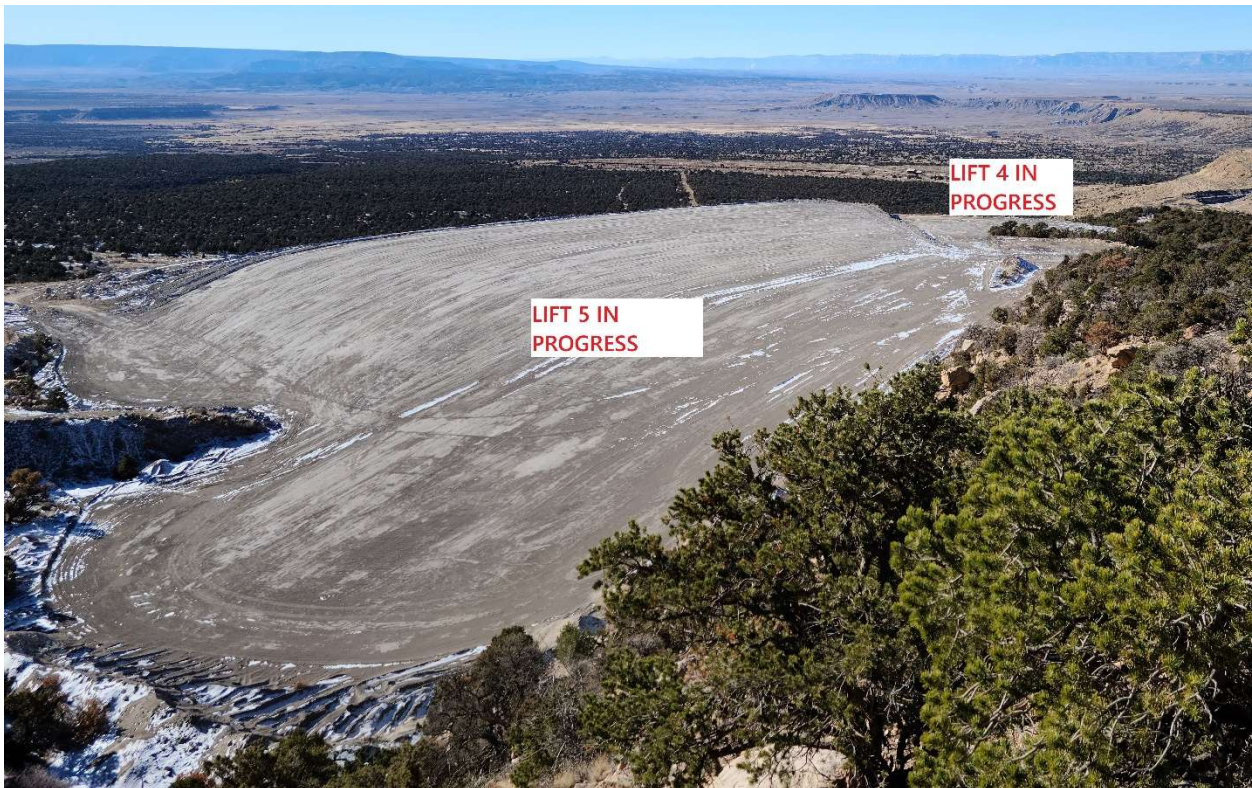
SCA#2 Ash Landfill – looking westerly
Lift #5 in progress

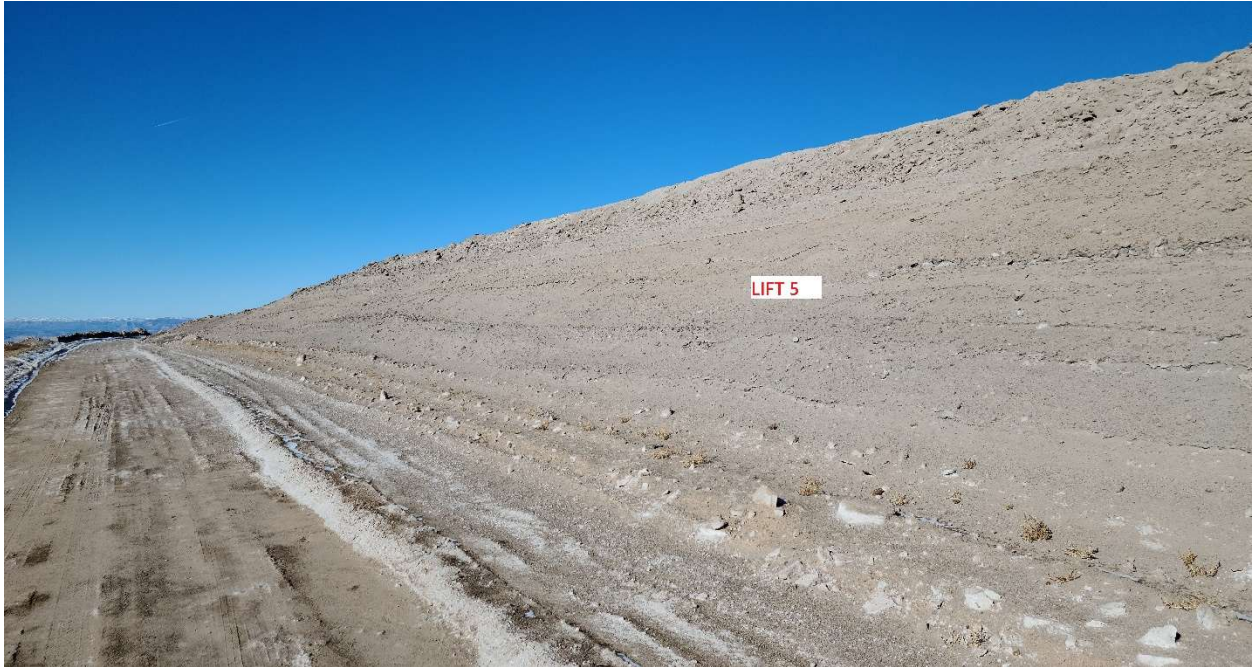
Lift #5 – in process – photo looking northwest

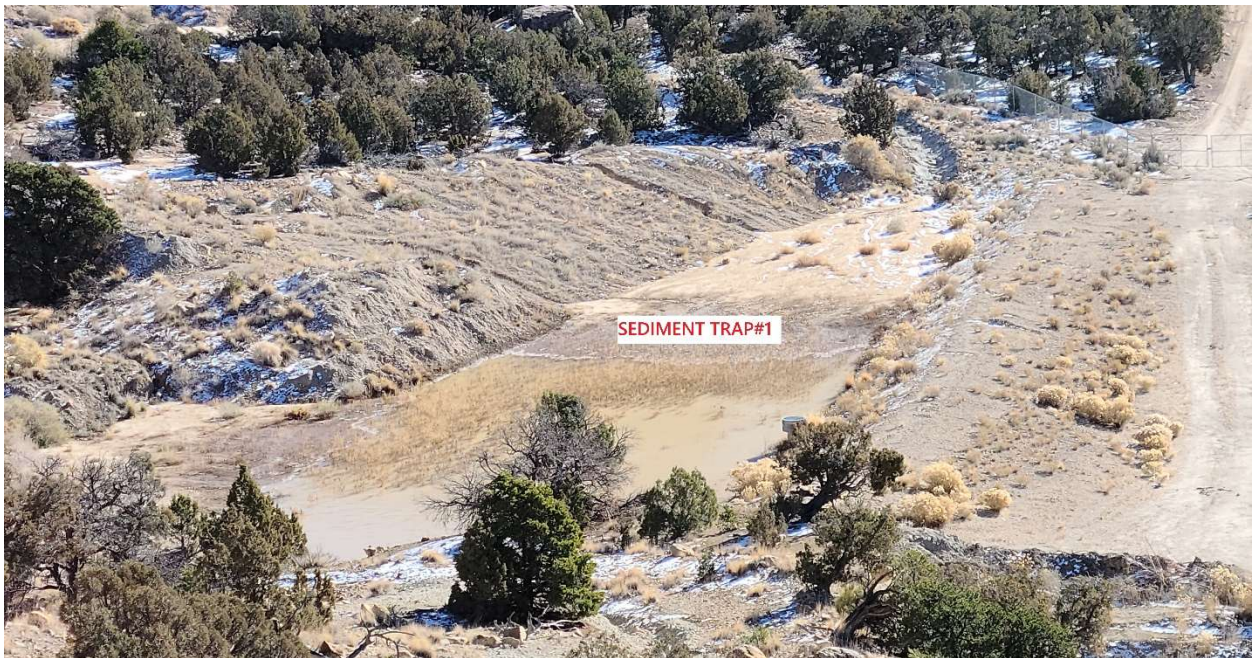
Sediment Trap #1 is has some water
water flows from trap #1 to pond 018 in normal open condition

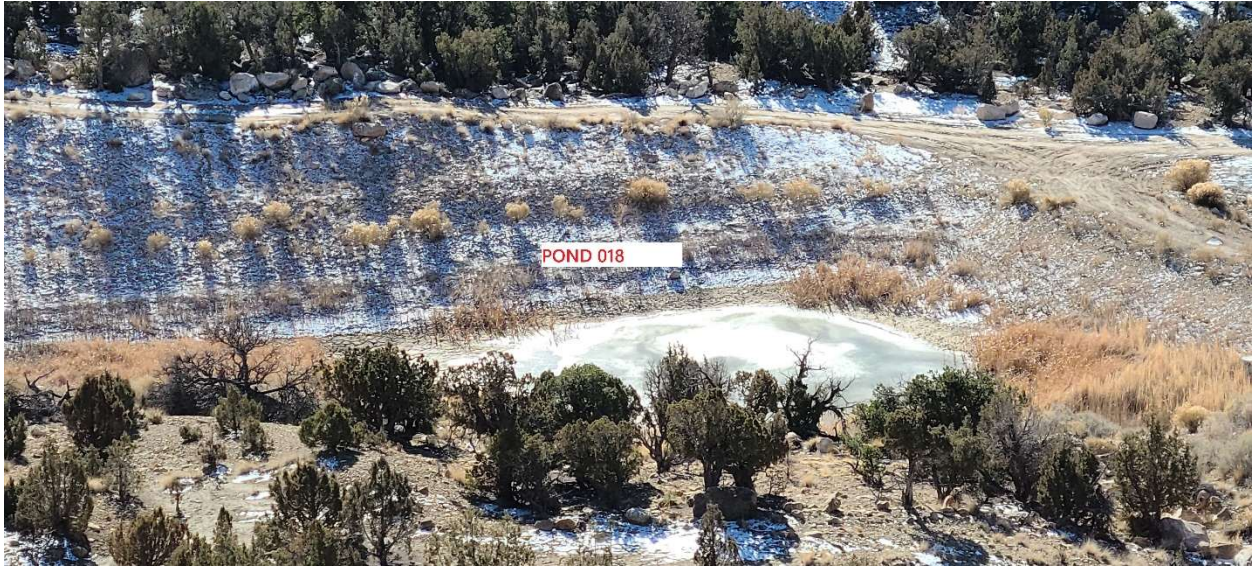
- iv. Sediment Trap #1 and Sediment Pond 018 are in operation west (downhill) of the landfill. No discharge recorded in 2025. Pond 018 had some water and ice in it at time of inspection.

Sediment Pond 018, located west of Sed Trap #1 – photo looking southerly
Pond has some water. - No discharge in 2025

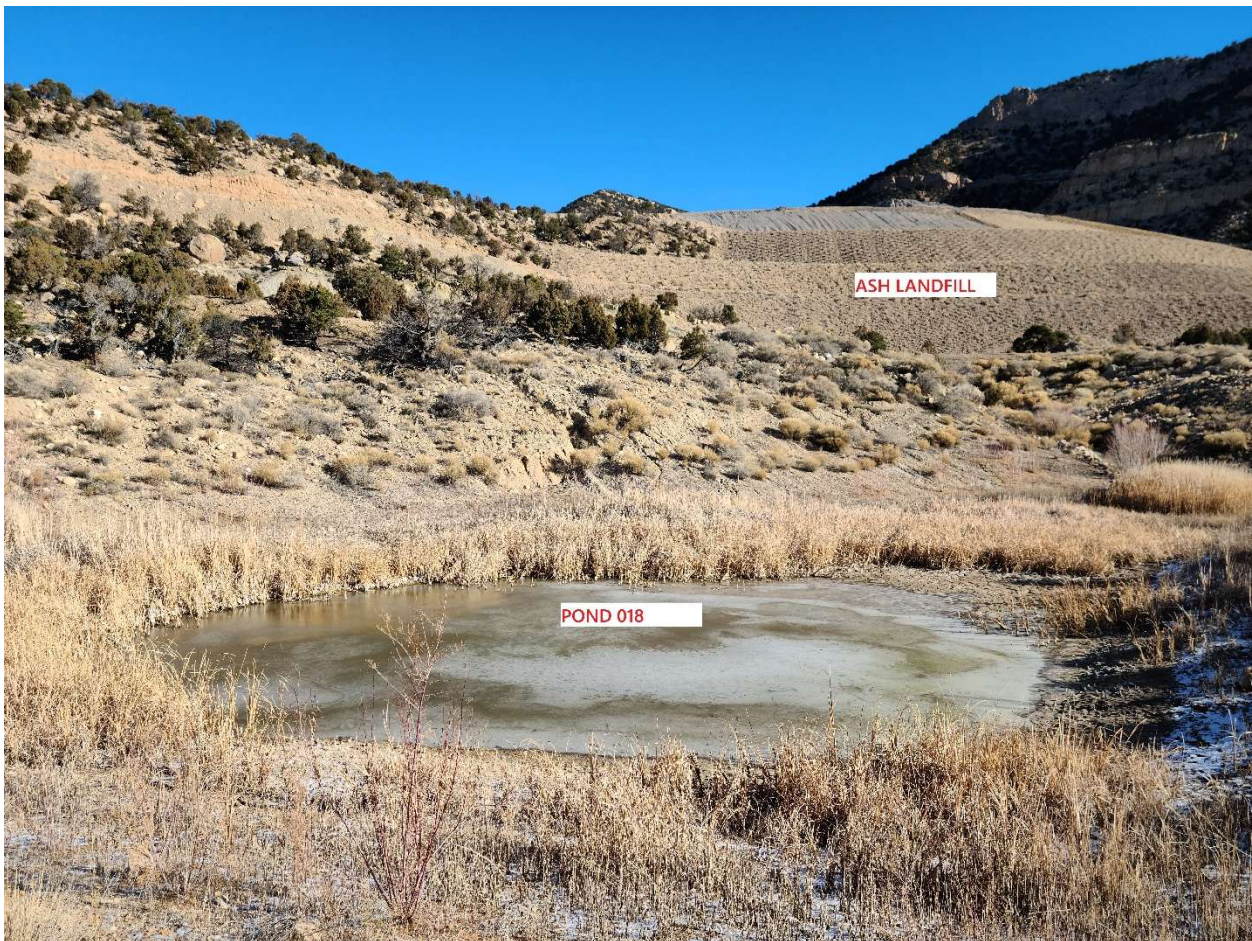
Sediment Pond 018 in foreground, Ash Landfill in background – photo looking easterly Dec 29, 2025
