SCA#2 Ash Landfill –looking southeasterly

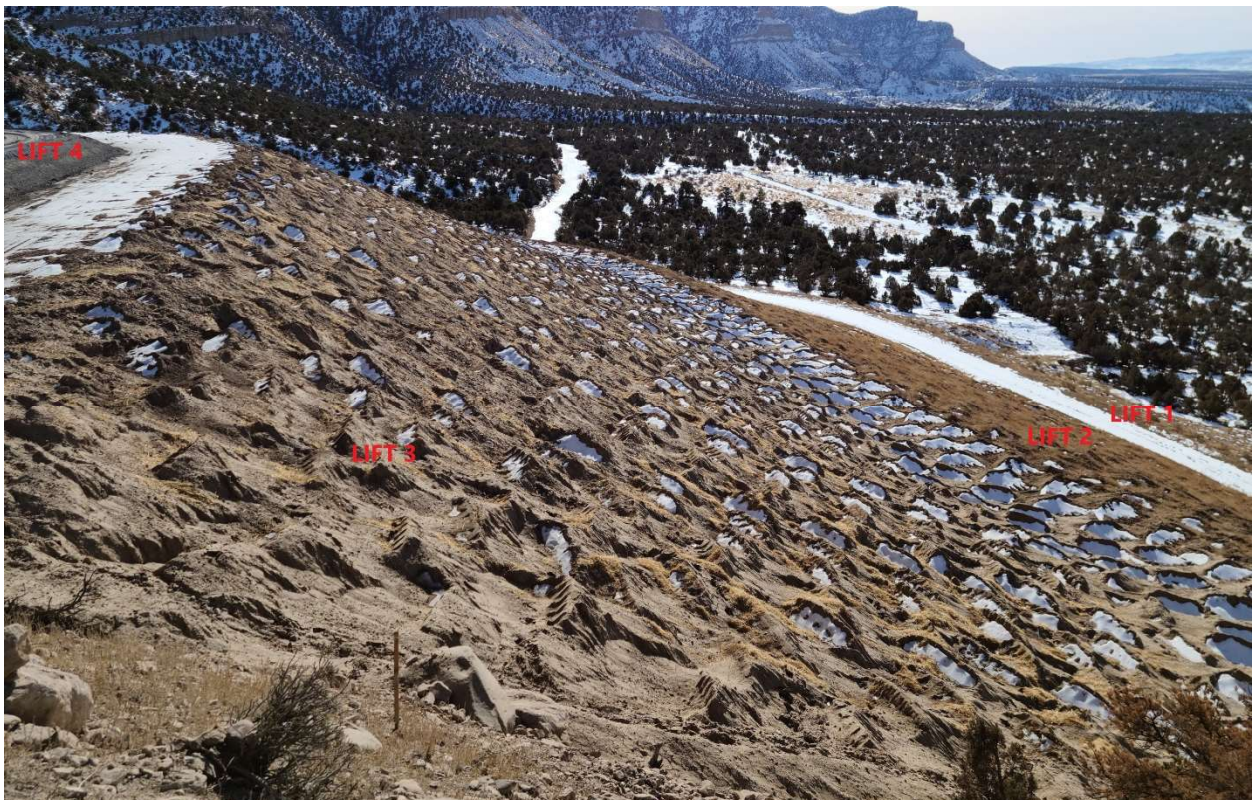
SCA#2 Ash Landfill – west face looking southerly  
Lift #1, #2 and #3 covered and seeded. Lift #4 in process

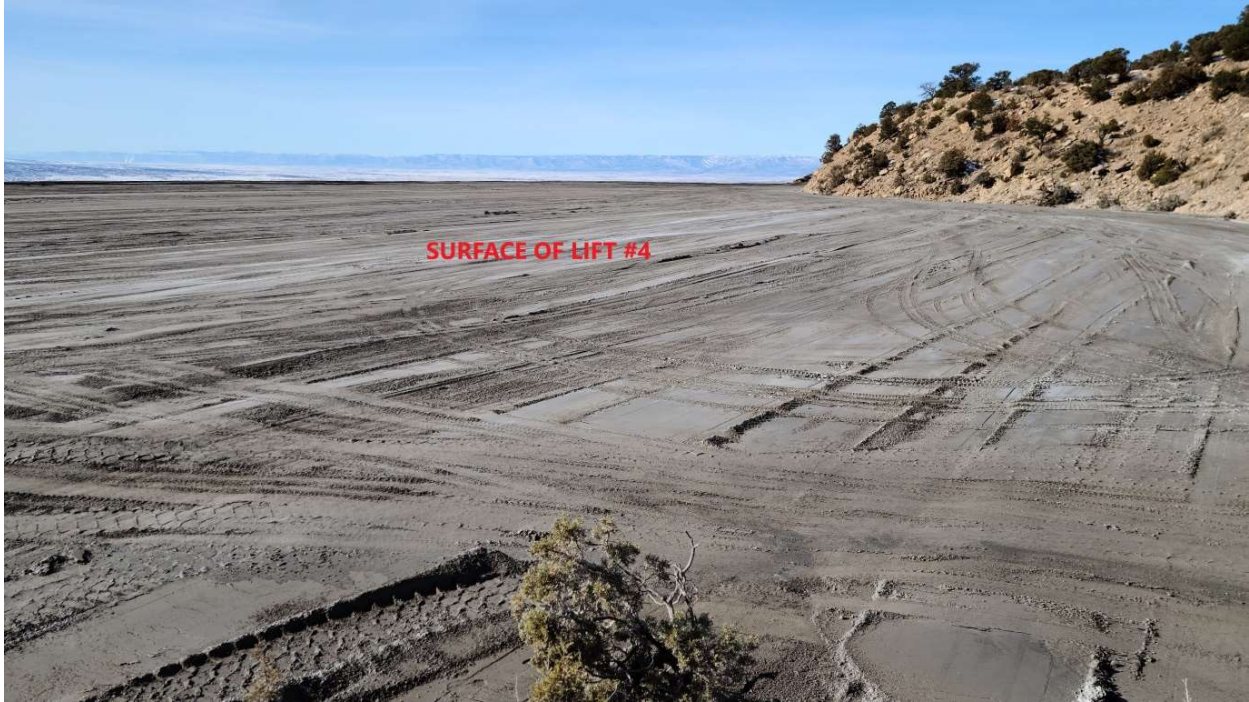
Surface of Lift #4 in process – photo looking northwesterly January 14, 2021  
Compaction appears satisfactory. Dust suppression appears satisfactory

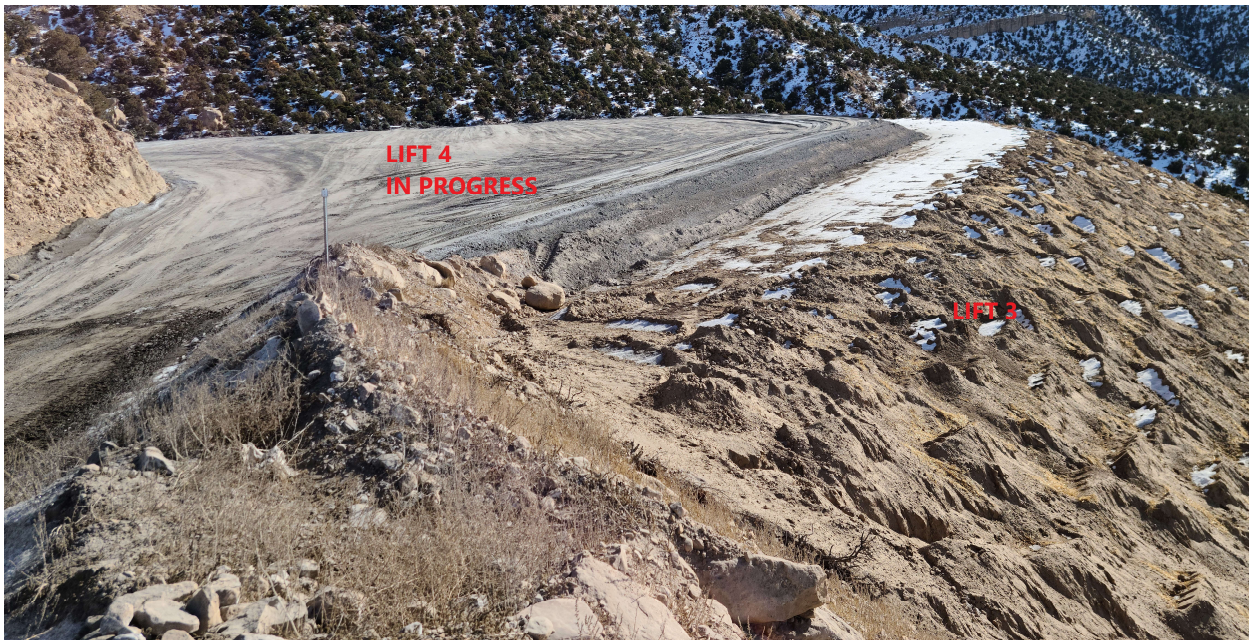
Surface of Lift #4 in process – photo looking south-southeast January 14, 2021

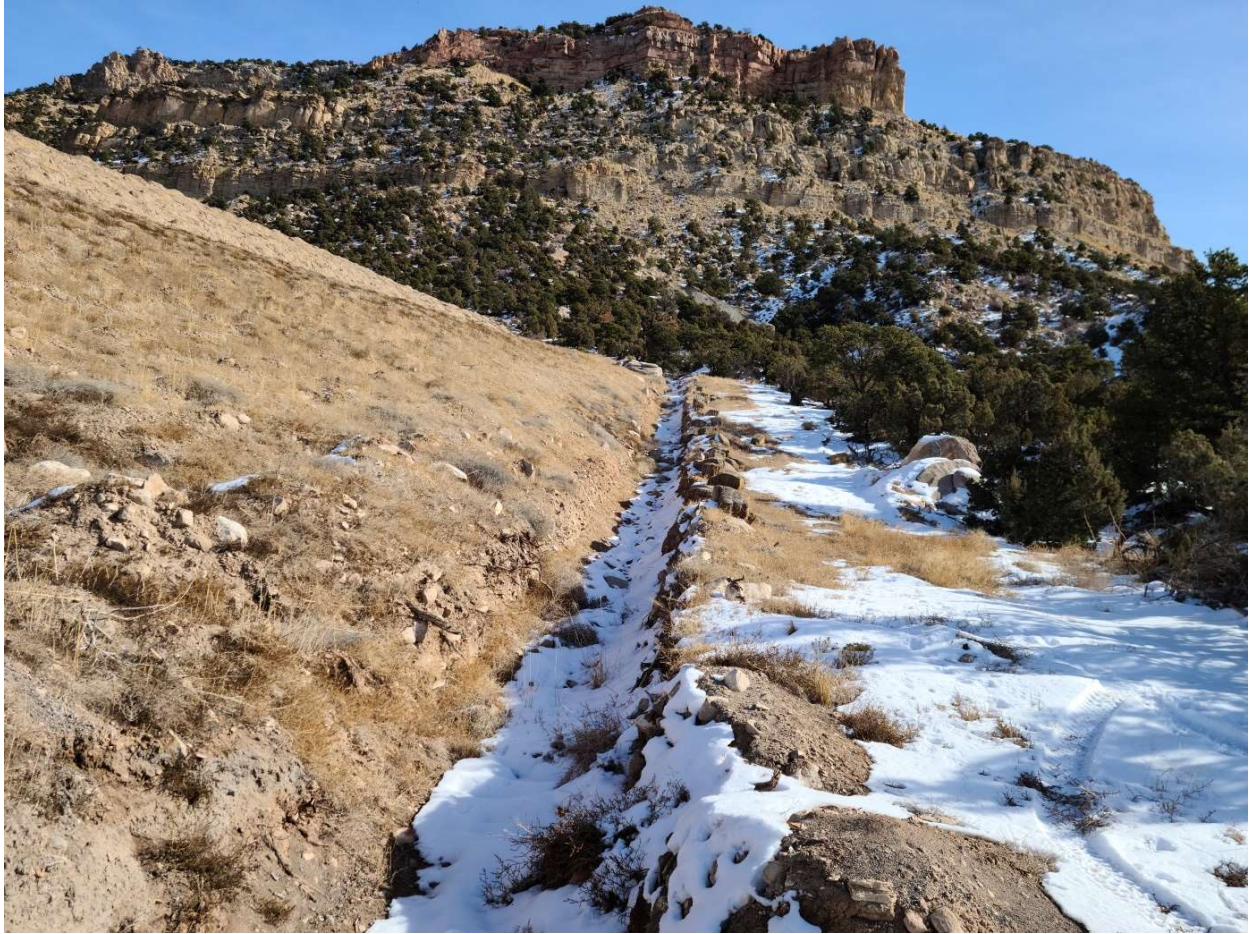
South Perimeter Ditch – looking easterly

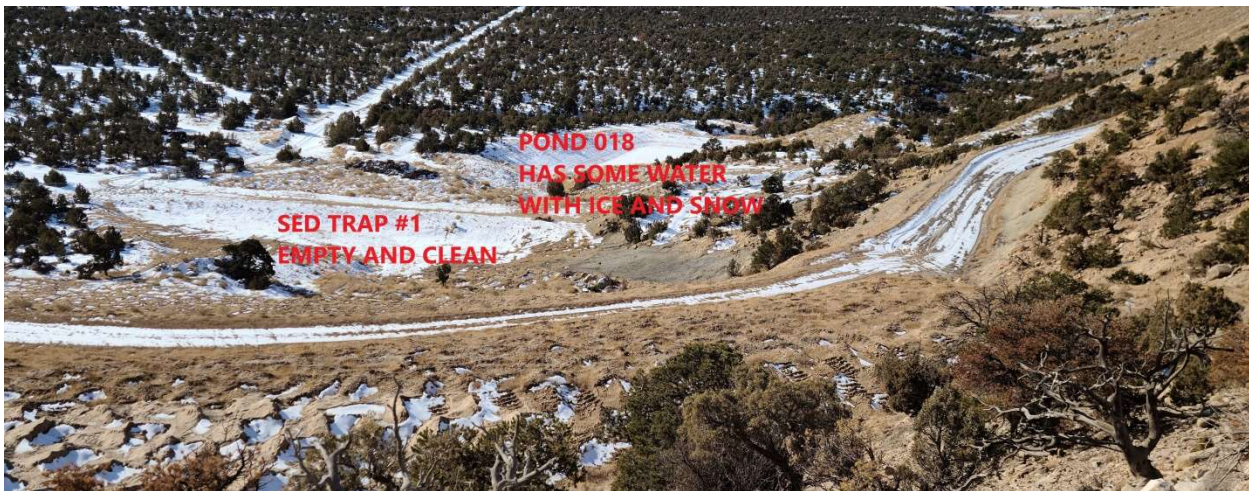
Sediment Pond 018, located west of Sed Trap #1 – photo looking westerly  
Pond has water with a surface ice layer and recent snow cover.  
No discharge in 2020  
Sediment Trap #1 is empty and clean, water flows from trap to pond in normal open condition.
