SCA#2 Ash Landfill –looking southeasterly

January 2, 2019

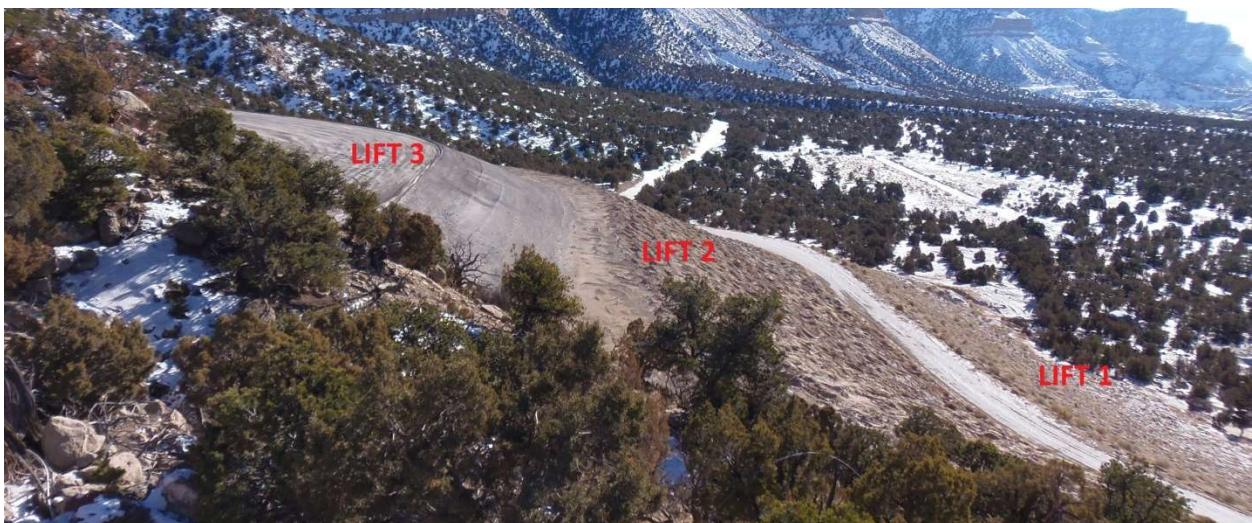
SCA#2 Ash Landfill – west face looking southerly  
Lift #1 and #2 covered and seeded, vegetation is growing. Lift #3 in process

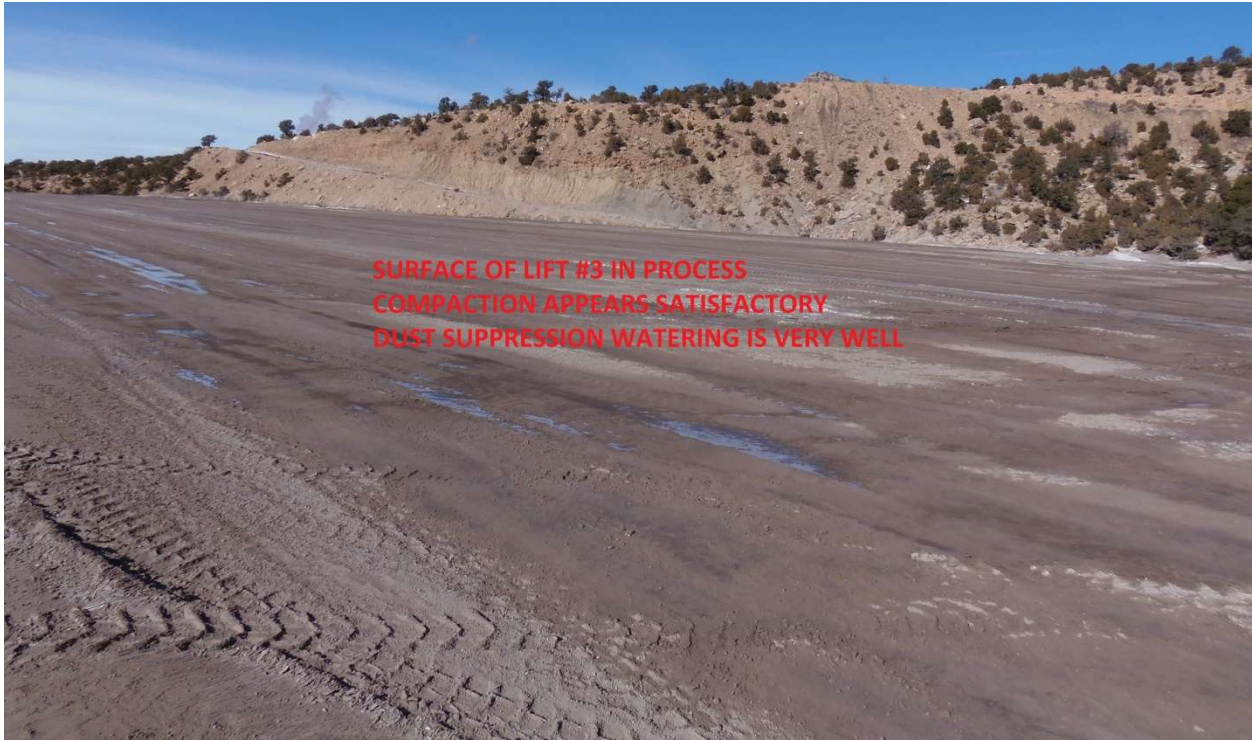
Surface of Lift #3 in process – photo looking northwesterly

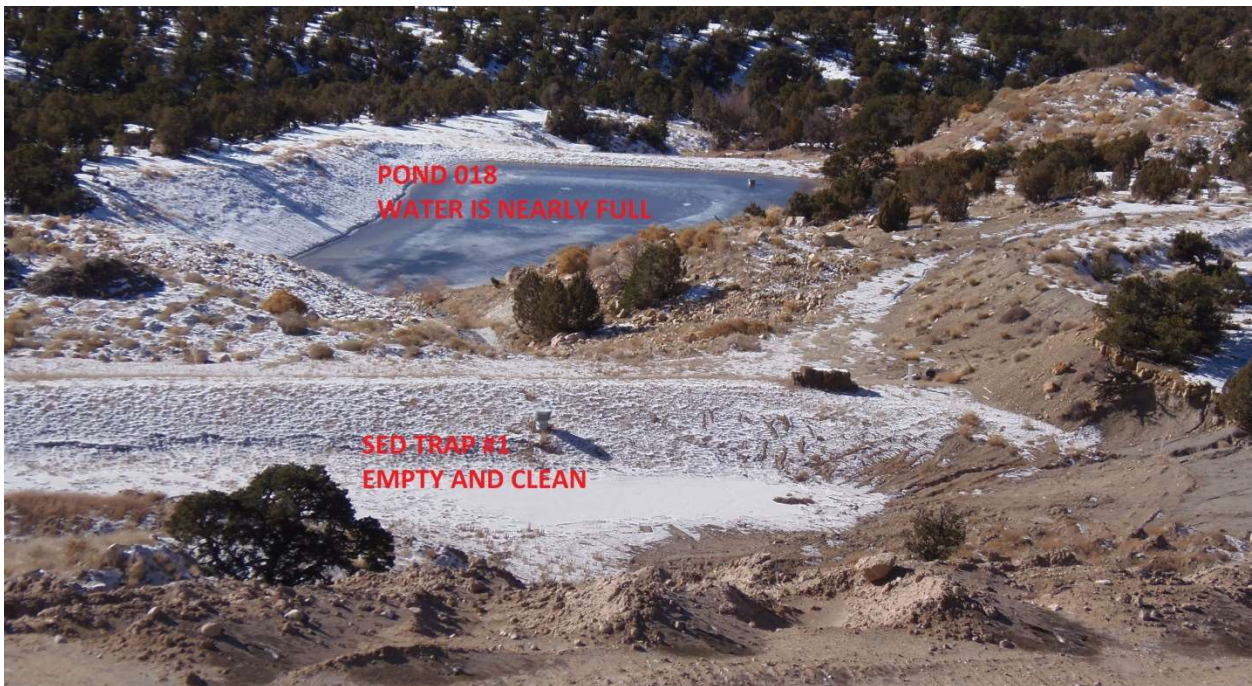
Sediment Pond 018, located west of Sed Trap #1 – photo looking westerly

Recent storms with ice reducing the evaporation and pond appears nearly full of water.

No discharge in 2018

Sediment Trap #1 is empty and clean, water flows from trap to pond in normal open condition.
